***Report No. UT-04.04***

***A STUDY OF THE I-15  
RECONSTRUCTION PROJECT  
TO INVESTIGATE VARIABLES  
AFFECTING BRIDGE DECK  
CRACKING***

**Utah Department of Transportation  
Research Division**

**July 2004**

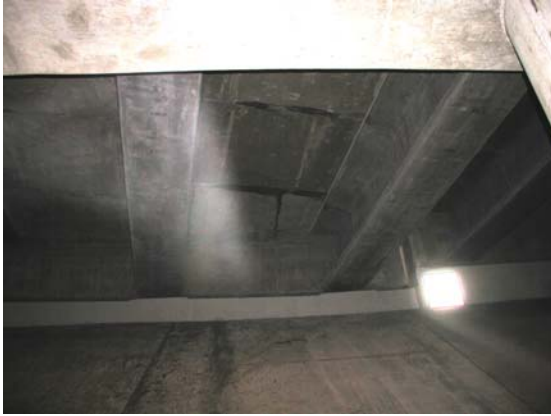
**Deck Underside near Abutment (Jan. 10, 2003)**

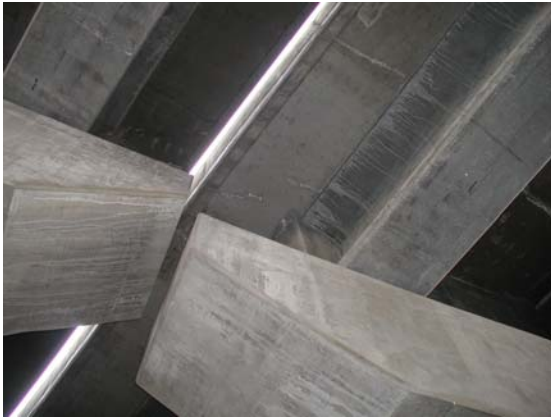
**Deck Underside near South Bent (May 21, 2003)**

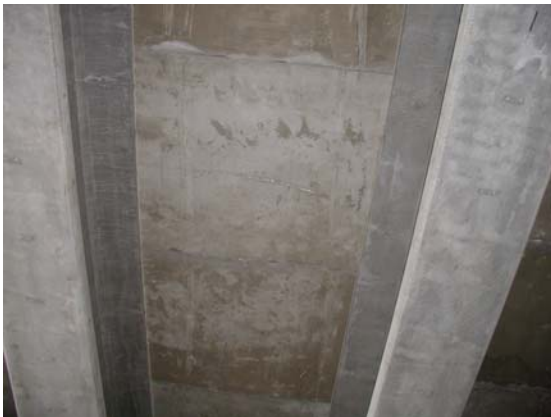
**Deck Underside near North Abutment (May 21, 2003)**

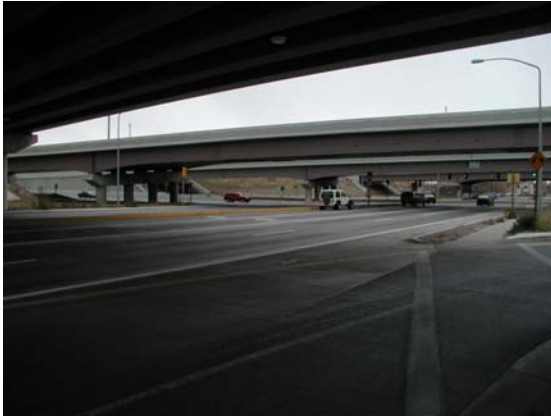
**Partial West Elevation (Dec. 21, 2002)**

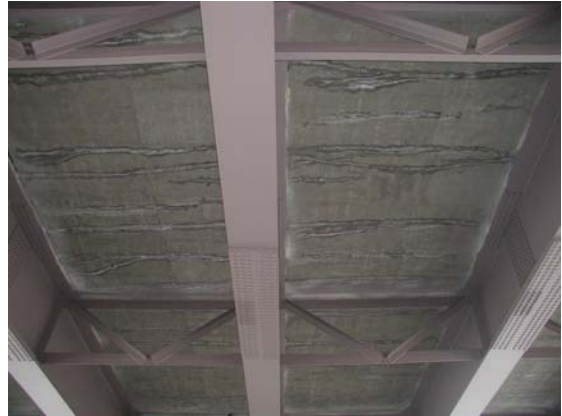
**Deck Underside (Jan. 10, 2003)**

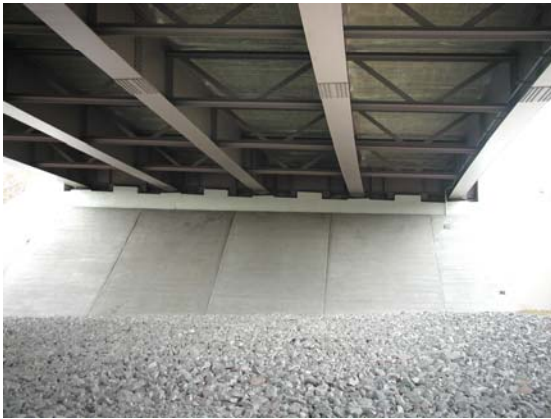
**North Abutment (Dec. 21, 2002)**

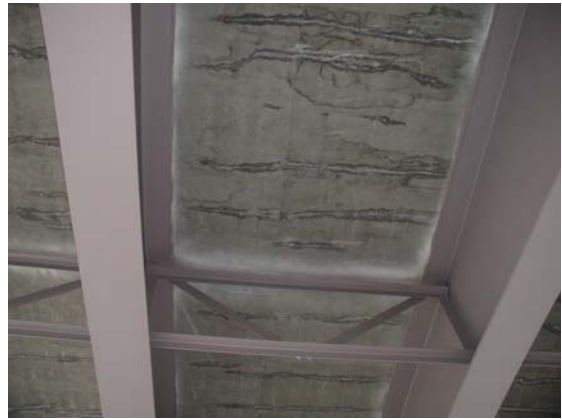
**Deck Underside (Jan. 10, 2003)**

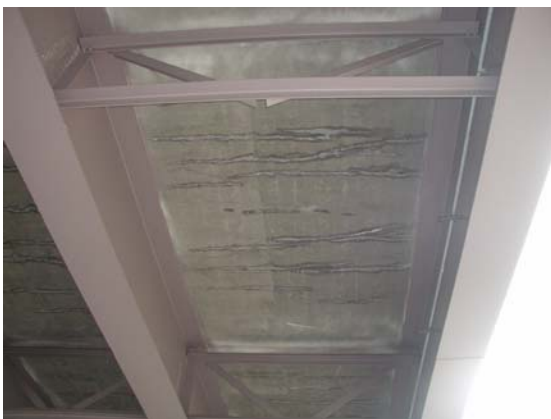
**Deck Underside (Jan. 10, 2003)**

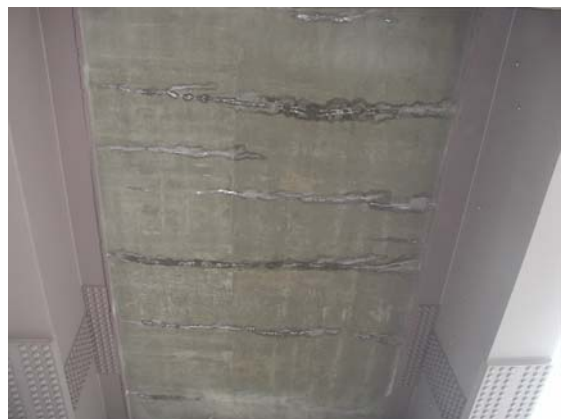
**Deck Underside (Feb. 25, 2003)**

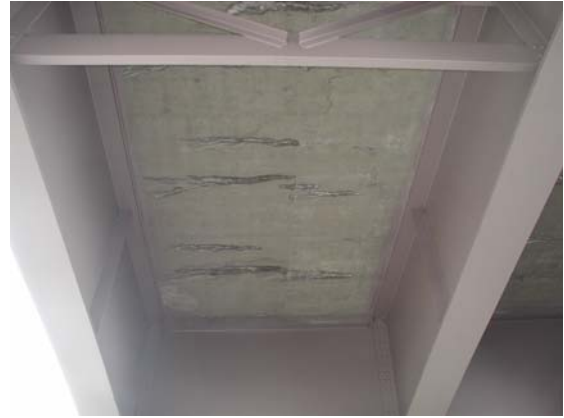
**Deck Underside (Feb. 25, 2003)**

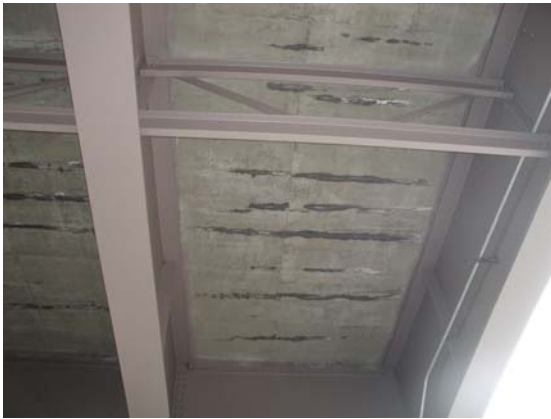
**Deck Underside (Jan. 10, 2003)**

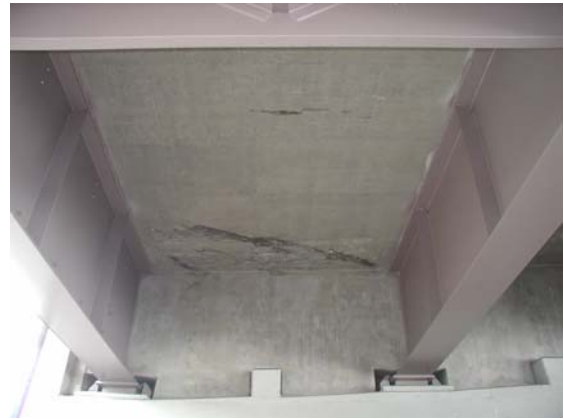
**South Abutment (Feb. 25, 2003)**

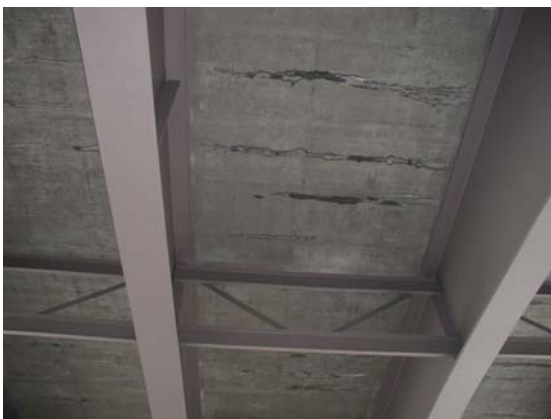
**Deck Underside (Jan. 10, 2003)**

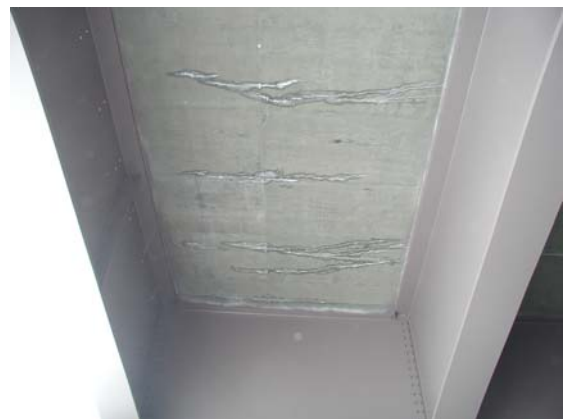
**Deck Underside (Feb. 25, 2003)**

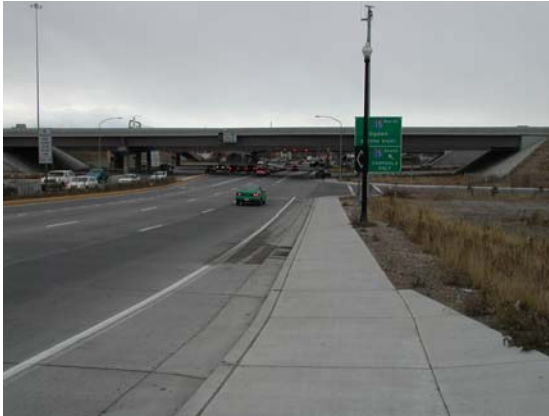
**West Elevation (Dec. 21, 2002)**

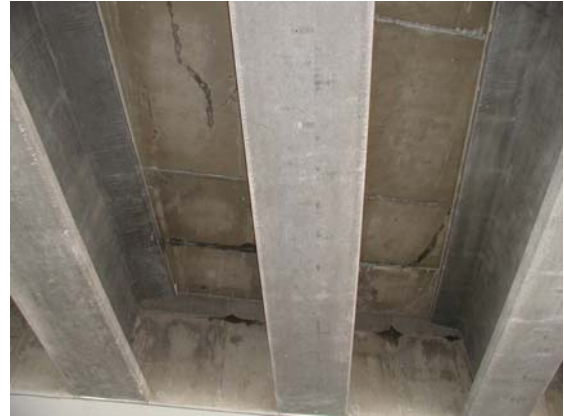
**North Abutment (Feb. 14, 2003)**

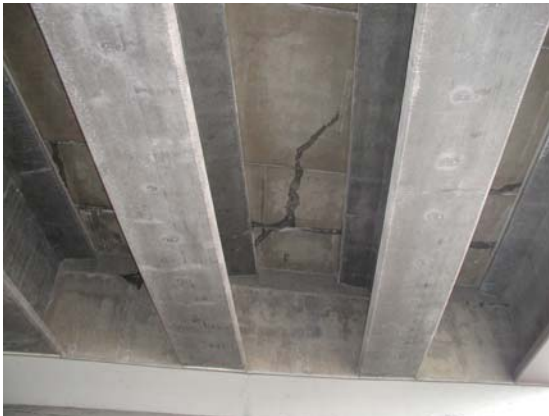
**North Abutment (Jan. 10, 2003)**

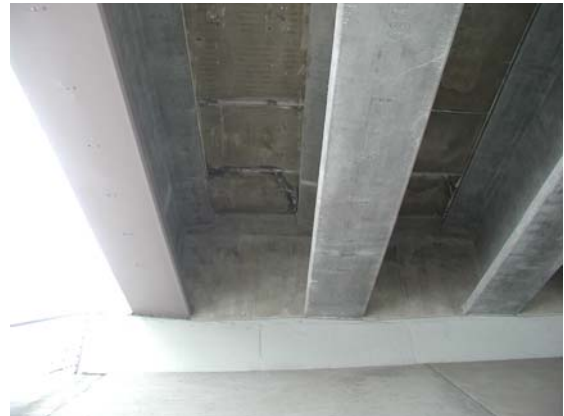
**South Abutment (Feb. 25, 2003)**

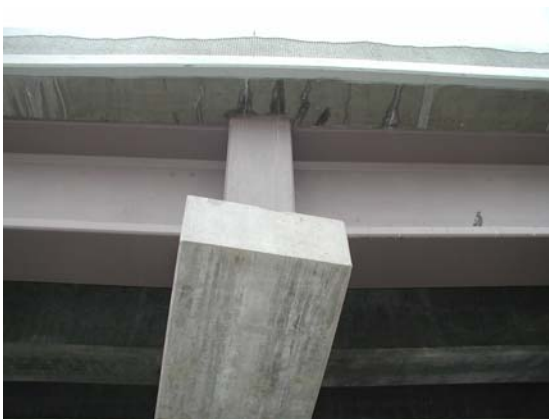
**East Side of North Bent (Feb. 14, 2003)**

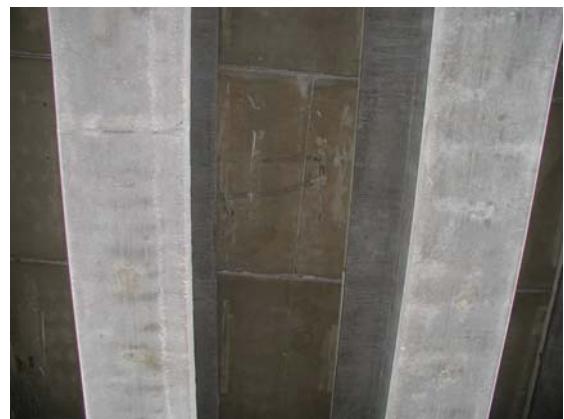
**Deck Underside (Feb. 25, 2003)**

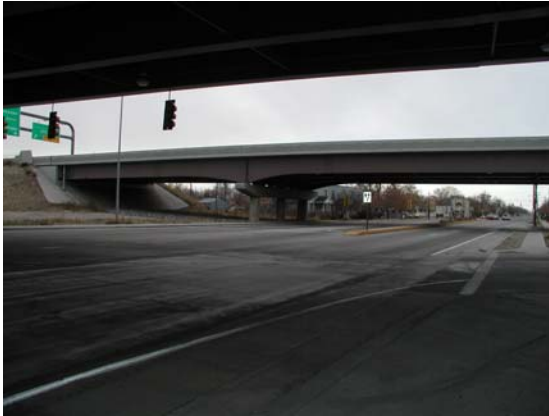
**Partial West Elevation (Dec. 21, 2002)**

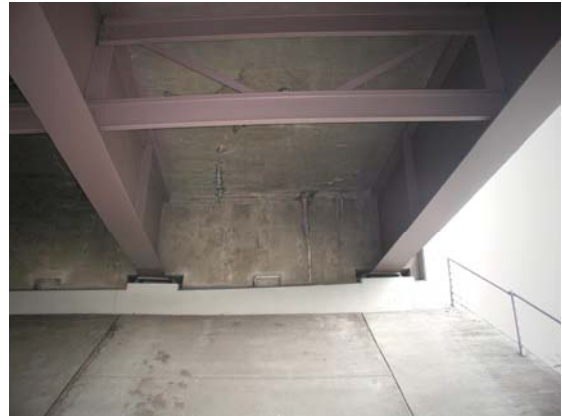
**North Abutment (Jan. 10, 2003)**

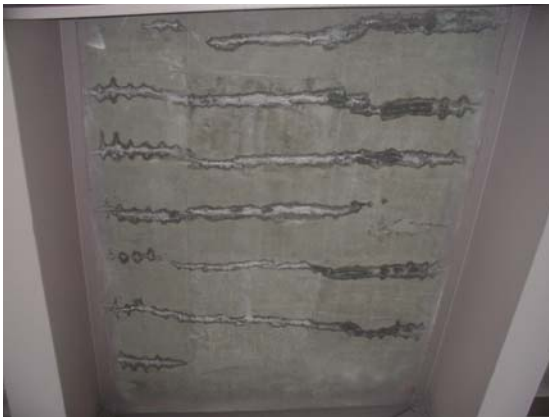
**Deck Underside (Jan. 10, 2003)**

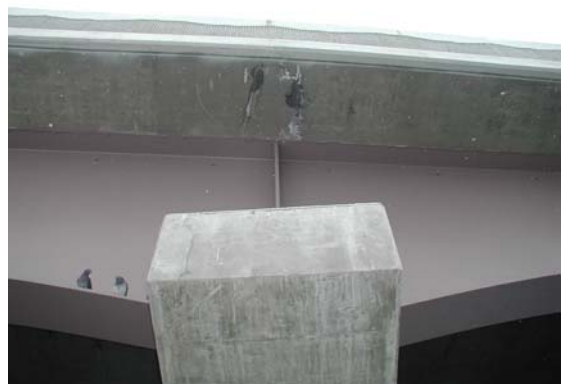
**East Side of South Bent (Feb. 25, 2003)**

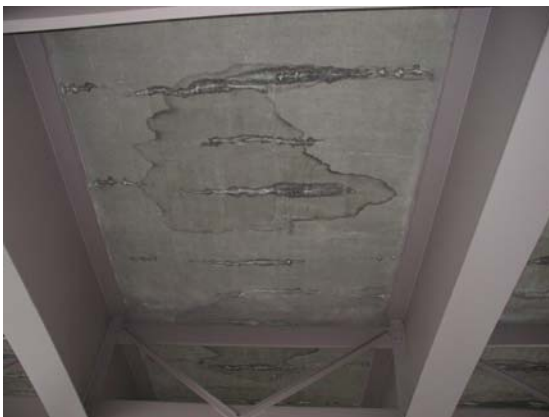
**Deck Underside (Jan. 10, 2003)**

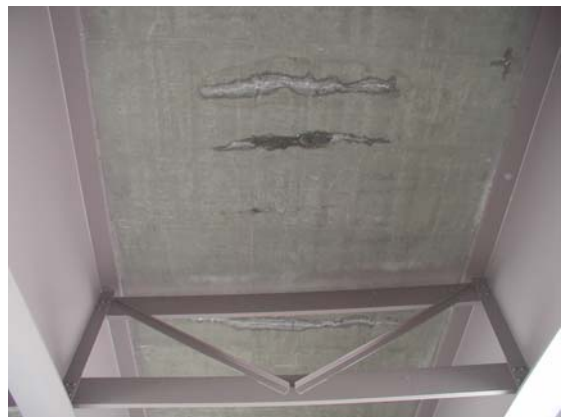
**Deck Underside (Feb. 25, 2003)**

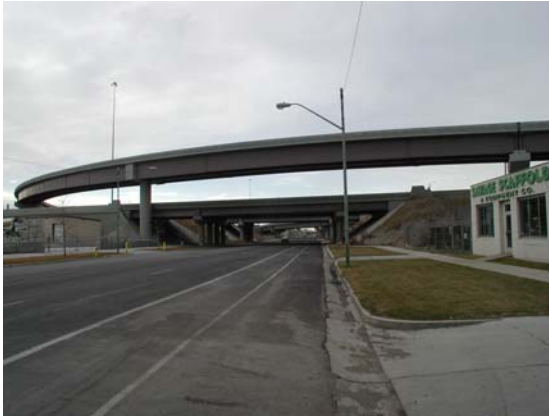
**West Elevation (Dec. 21, 2002) [the lower bridge]**

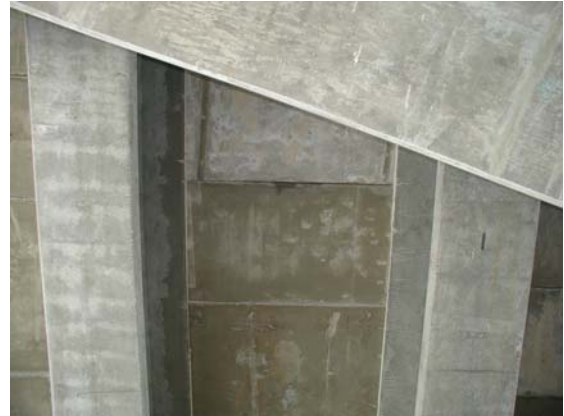
**Deck Underside just South of North Bent (Feb. 14, 2003)**

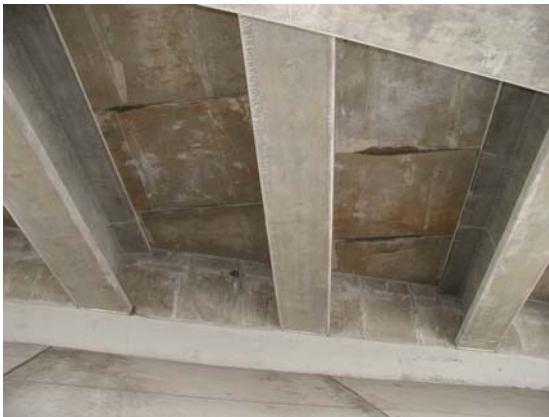
**North Abutment (Feb. 14, 2003)**

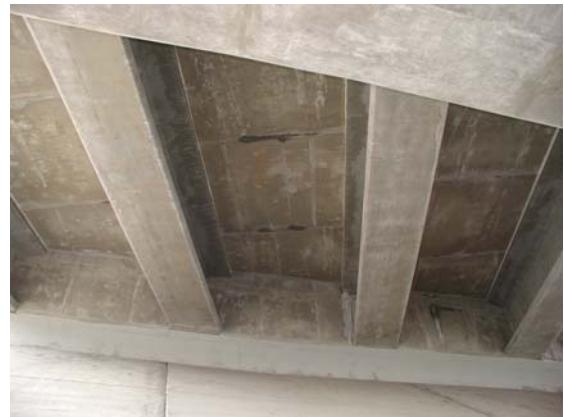
**South Abutment (Feb. 14, 2003)**

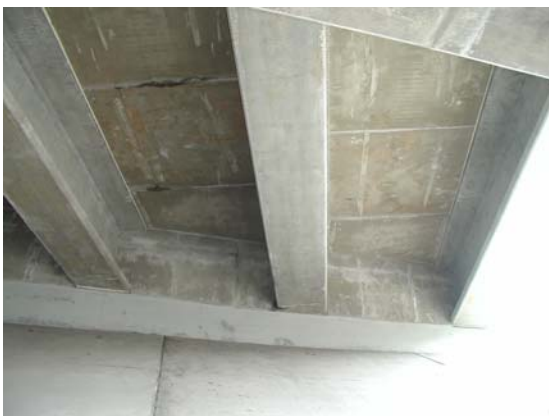
**North Abutment (Feb. 14, 2003)**

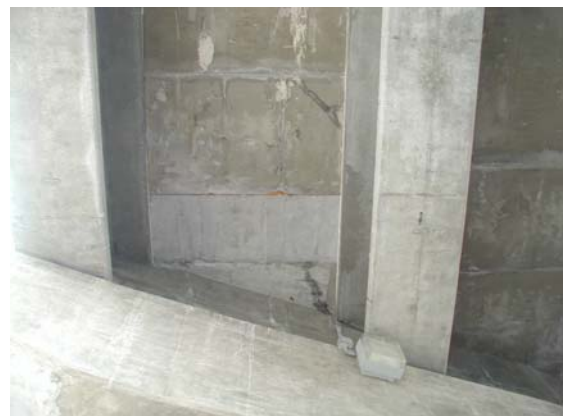
**Deck Underside just North of South Bent (Feb. 14, 2003)**

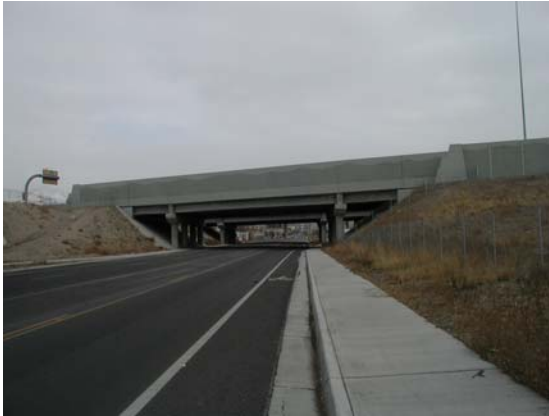
**East Elevation (Dec. 21, 2002)**

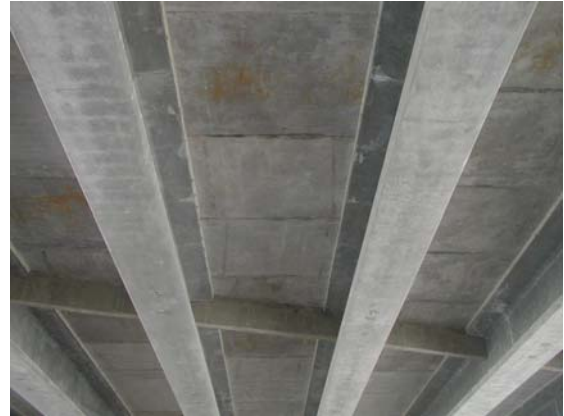
**Deck Underside Looking South (Feb. 14, 2003)**

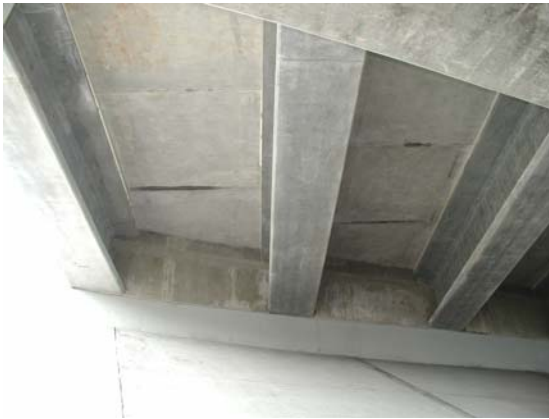
**North Abutment (Feb. 14, 2003)**

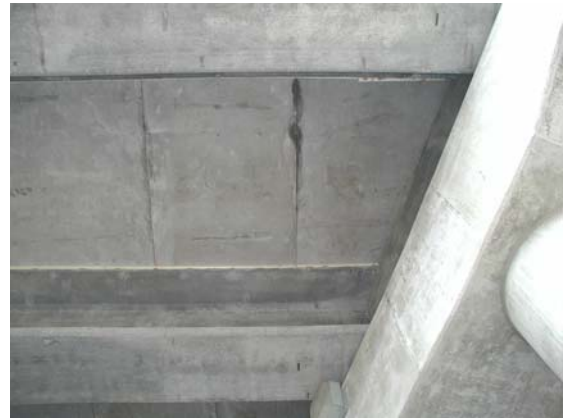
**Deck Underside just North of North Bent (Feb. 14, 2003)**

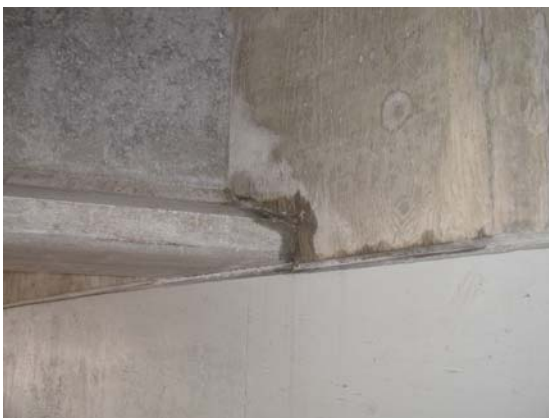
**North Abutment (Feb. 14, 2003)**

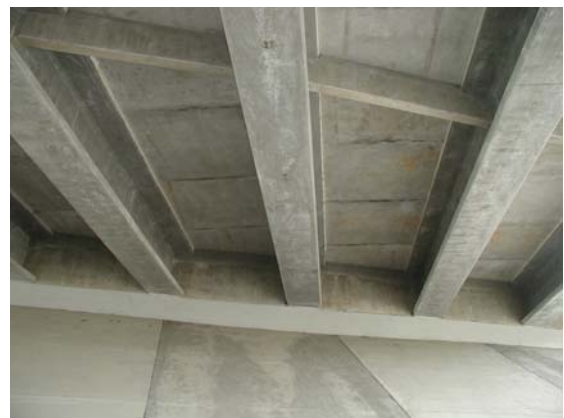
**South Abutment (Feb. 14, 2003)**

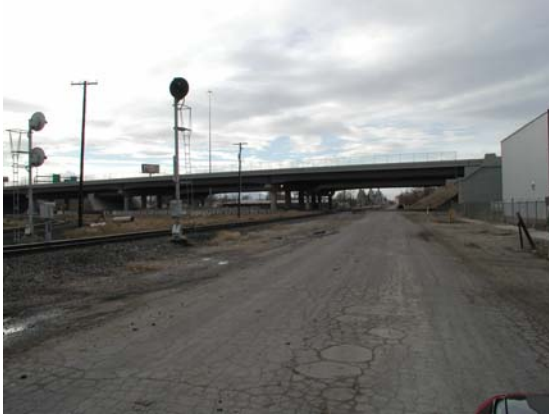
**Partial West Elevation (Dec. 21, 2002)**

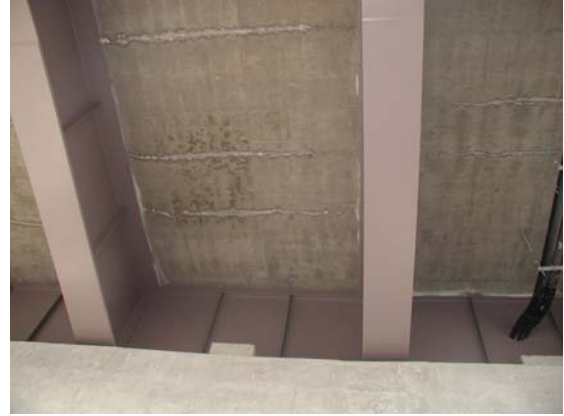
**Deck Underside (Jan. 4, 2003)**

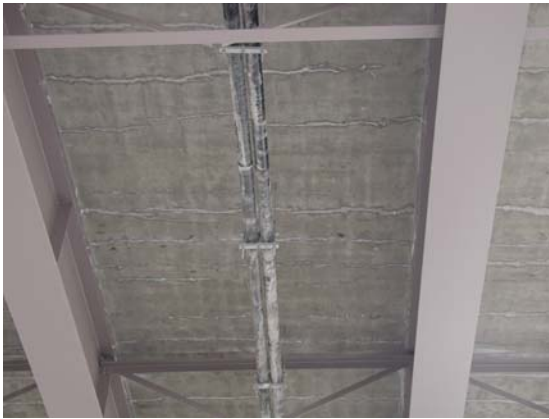
**Deck Underside (Dec. 21, 2002)**

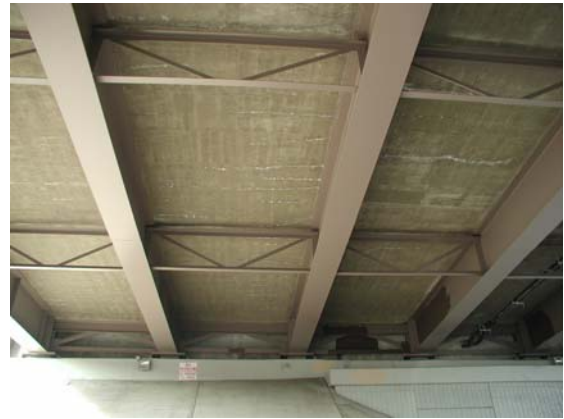
**North Abutment (Jan. 4, 2003)**

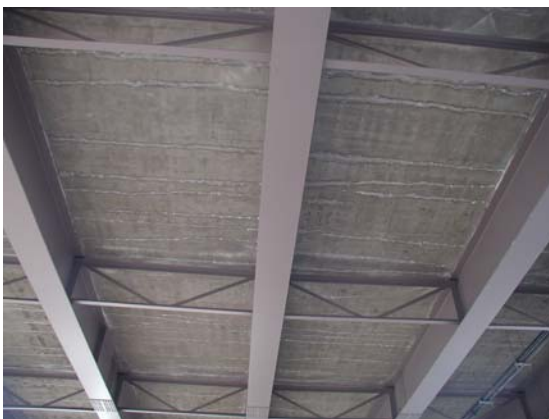
**Deck Underside (Jan. 4, 2003)**

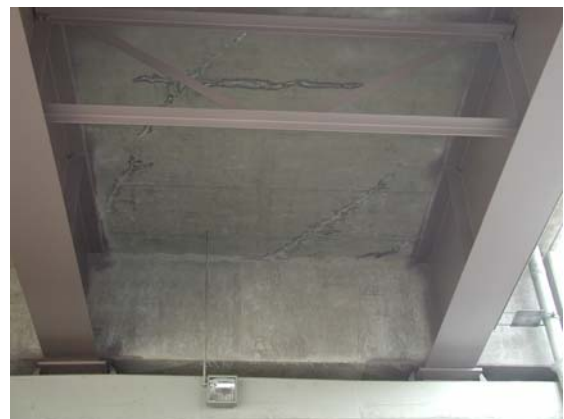
**North Abutment (Jan. 4, 2003)**

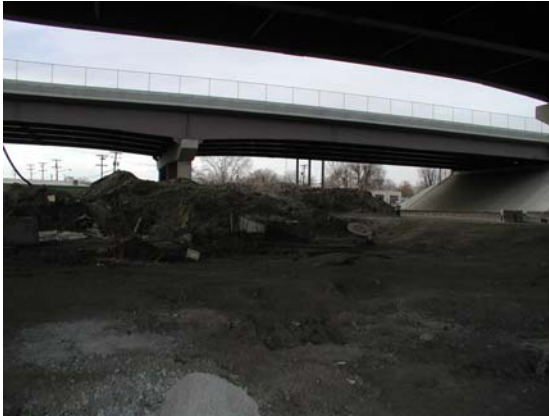
**Partial West Elevation (Dec. 21, 2002)**

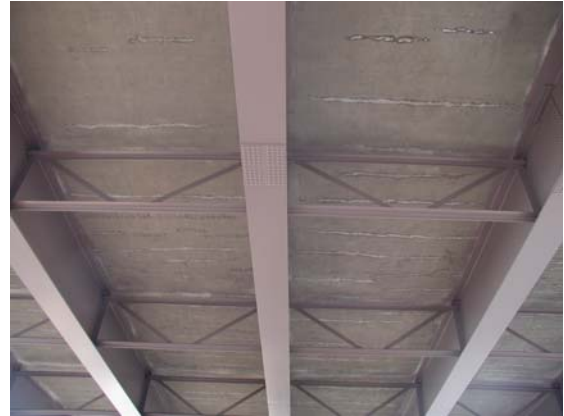
**Deck Underside (Jan. 4, 2003)**

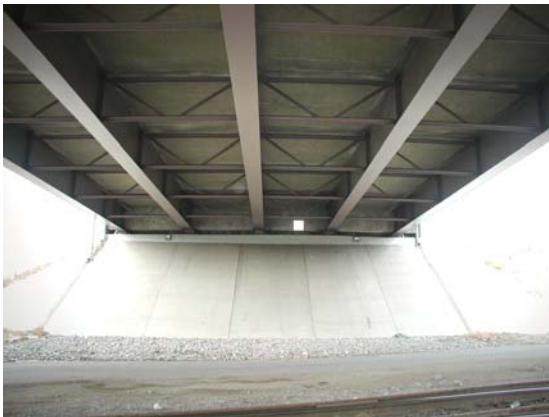
**North Abutment (Dec. 21, 2002)**

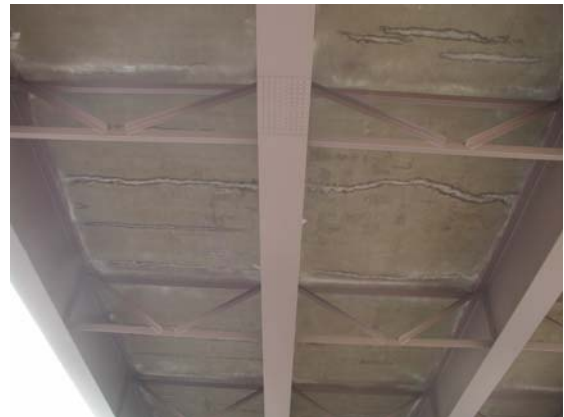
**Deck Underside (Jan. 4, 2003)**

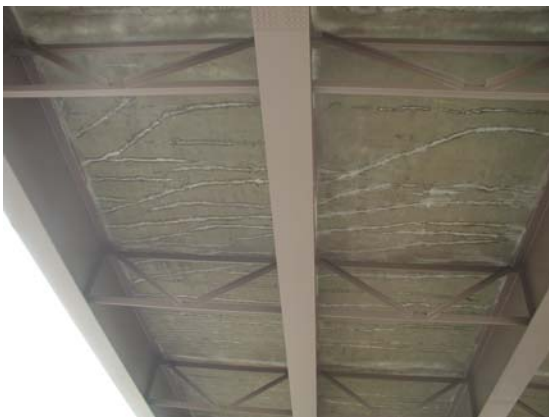
**Deck Underside (Jan. 4, 2003)**

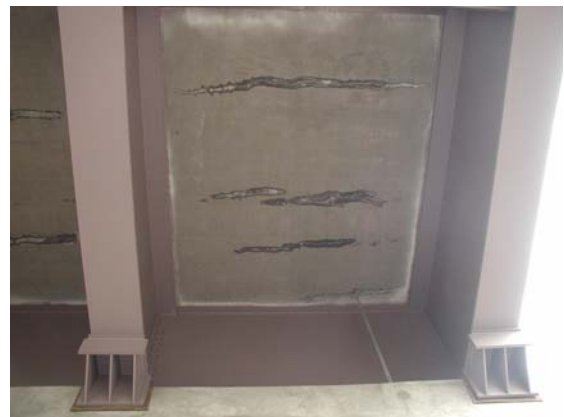
**Deck Underside (Jan. 10, 2003)**

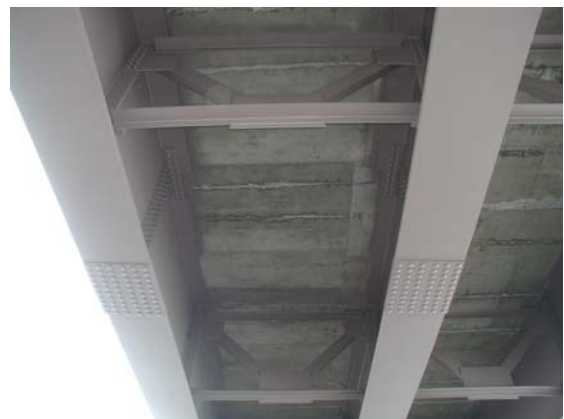
**Deck Underside (Feb. 25, 2003)**

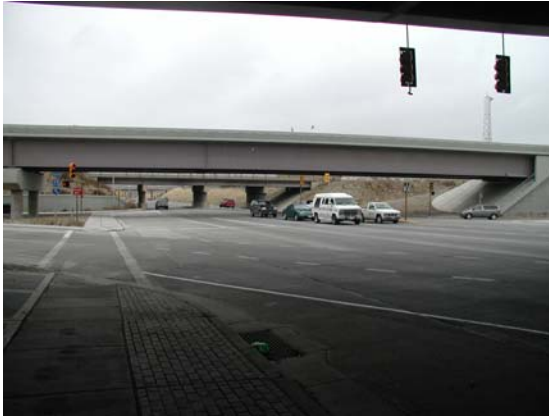
**Partial West Elevation (Dec. 20, 2002)**

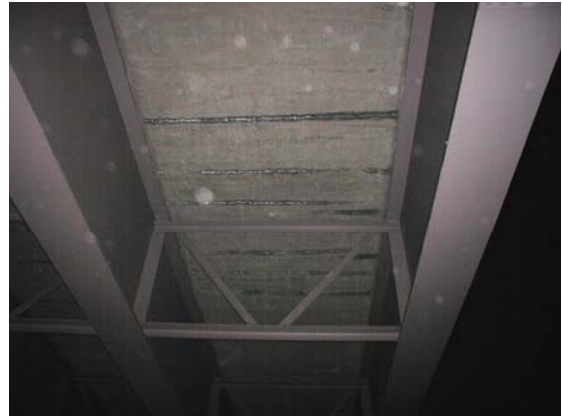
**Deck Underside (Jan. 28, 2003)**

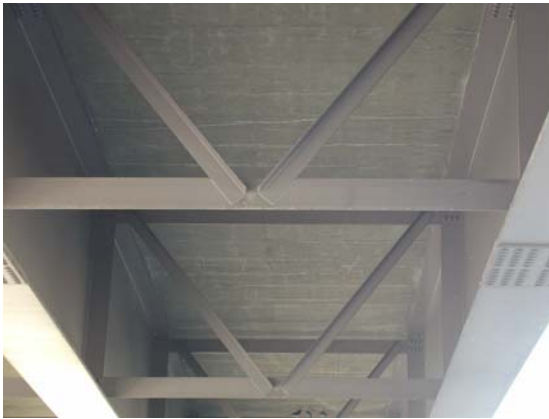
**Deck Underside (Jan. 8, 2003)**

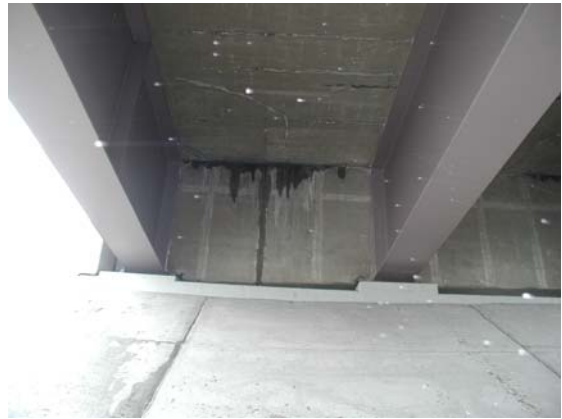
**North Abutment (Feb. 2, 2003)**

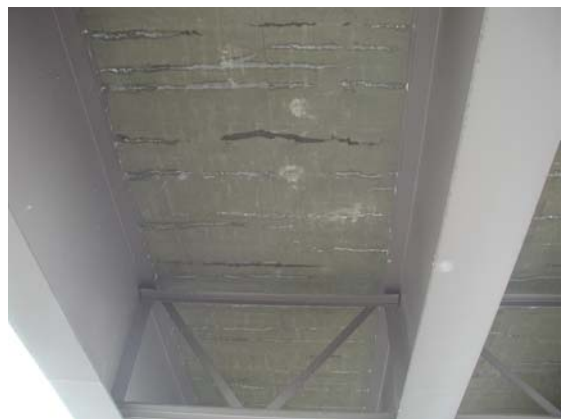
**Deck Underside (Feb. 2, 2003)**

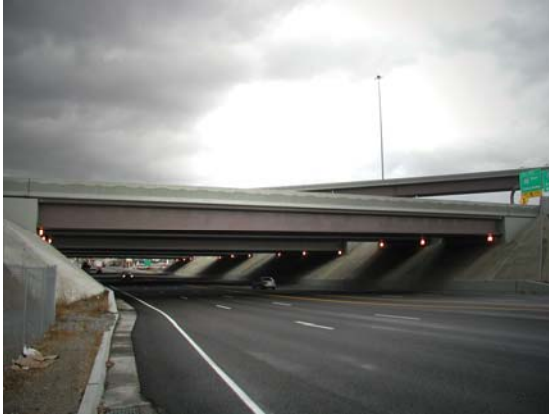
**East Elevation (Dec. 17, 2002)**

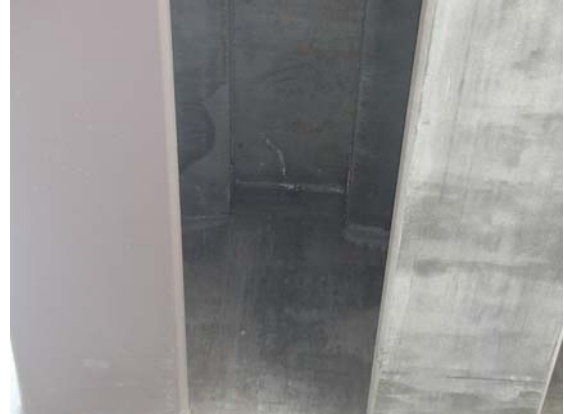
**South Abutment (Feb. 14, 2003)**
